IV. Conservation Actions

C. Watershed, Riparian, and Aquatic Habitat Restoration

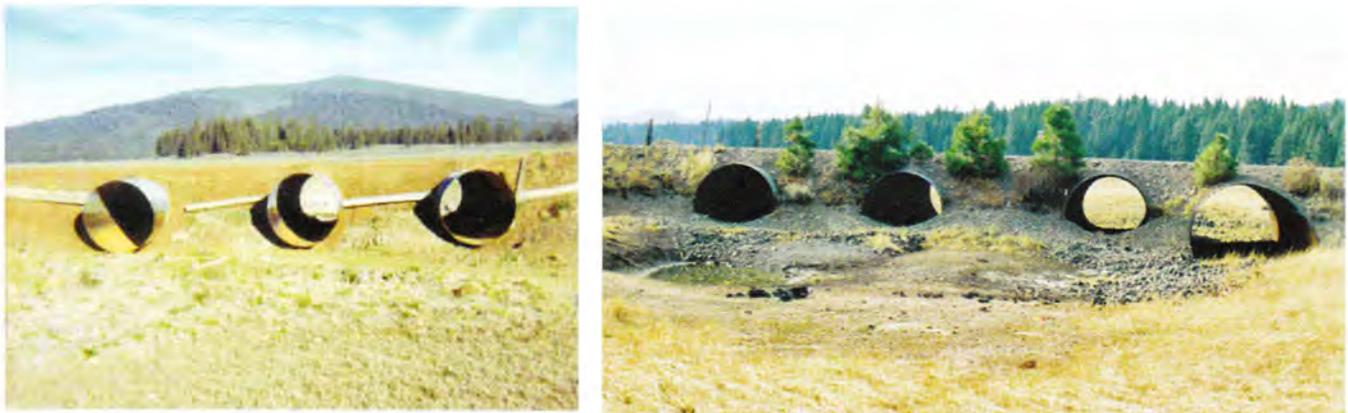
Figure 10. 105 Road Culverts. Left, 1976, looking downstream, Antelope Mt. in background. Right, 2005, looking upstream. Note largest culvert on far right showing low flow, below grade channel.

In 1992, Jones and Stokes prepared a report detailing fish passage problems and recommendations for repair. Their report looked closely at abandoned railroad grades approximately 3 miles downstream of Highway 44, the 105 Road culverts, the Camp 10 Road culverts, and the Logan Springs abandoned grades. They recommended leaving the abandoned grades in place as the benefits of ponding and attenuating peak flows may benefit fish passage. Reconnection of historic channels would be an acceptable compromise, i.e., “punching” holes through the grades in strategic places to allow stream flow continuity. Recommendations on the pre-existing culverts on the 105 and Camp 10 Roads were to leave the culverts in place, as the amount of fish passage days (days of excessive flow or velocity) weren’t an issue. Culverts at each of these locations, however, were replaced in 1994 through cooperative effort between LNF and Lassen County. At each site, a larger culvert placed below the streambed is now functioning as a low flow, natural bottom passage.

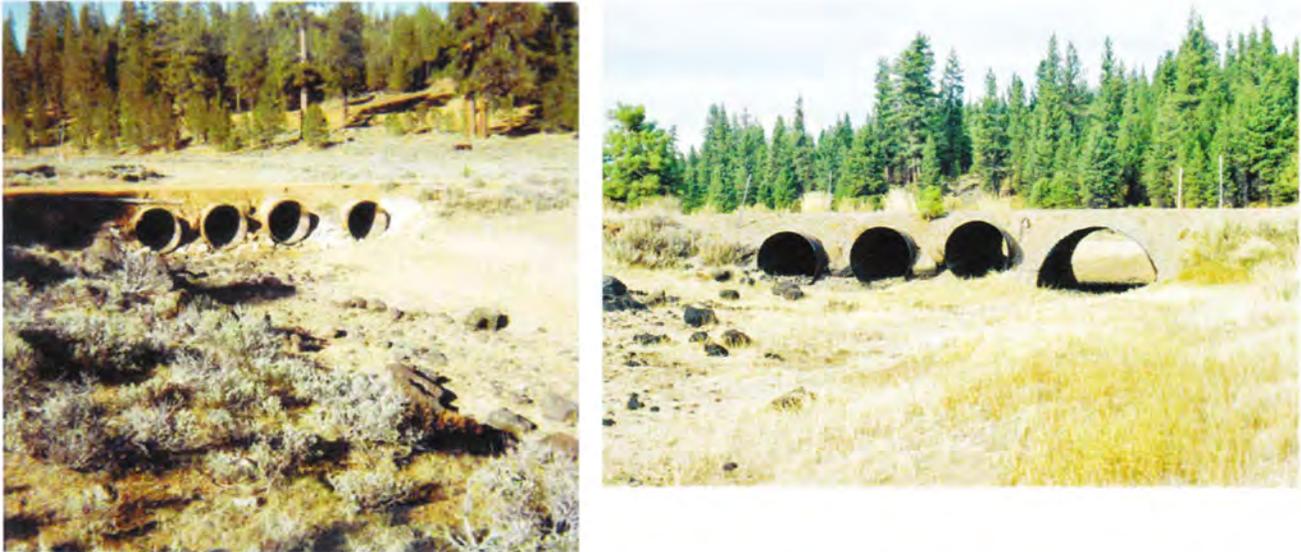
Figure 11. Camp 10 Road Culverts. Left 1976, looking downstream. Right, 2005, looking downstream. Note largest culvert on far right showing low flow, below grade channel.

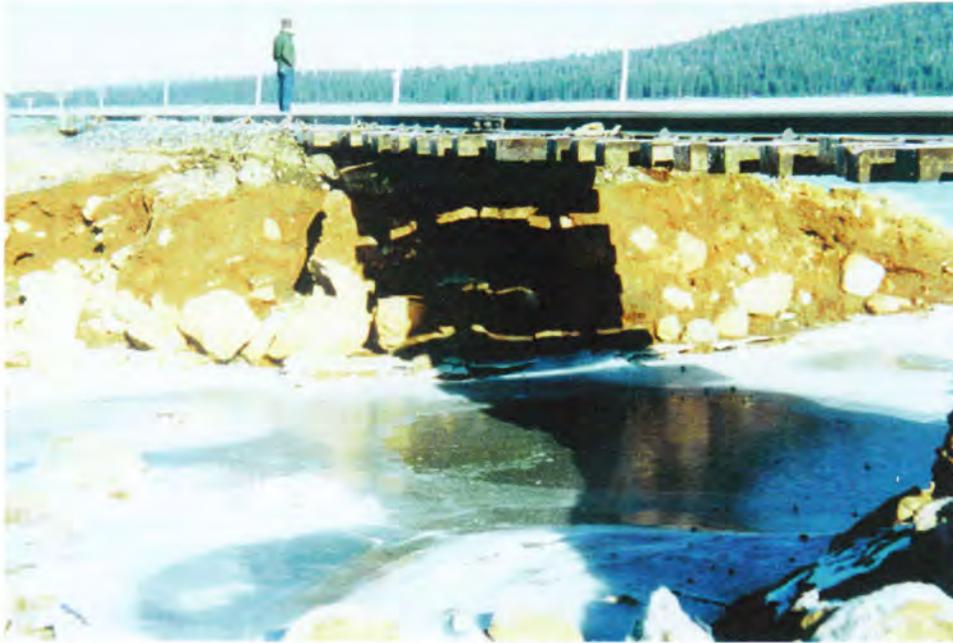
Figure 12. Union Pacific Railroad grade washout in the vicinity of County Rd 112 and Highway 44. January 1997.

The washout highlighted the need for further drainage needs across the valley. It was assumed at the time that a ditch constructed in the 1930's would pass flood flows from the vicinity of the highway with its ever-increasing traffic. Funneling all the braided channels of Pine Creek across the valley into few channels and culverts/trestles resulted in inadequate capacity of the culvert and backed up water in the natural channels to the point they overflowed their banks during high flows. One such event was reported to have caused an accident involving a rollover of a cement truck in the 1960's (CRMP notes 1994), leading to the creation of the present day "superditch" that until 1999 carried only one stream channel across Highway 44.

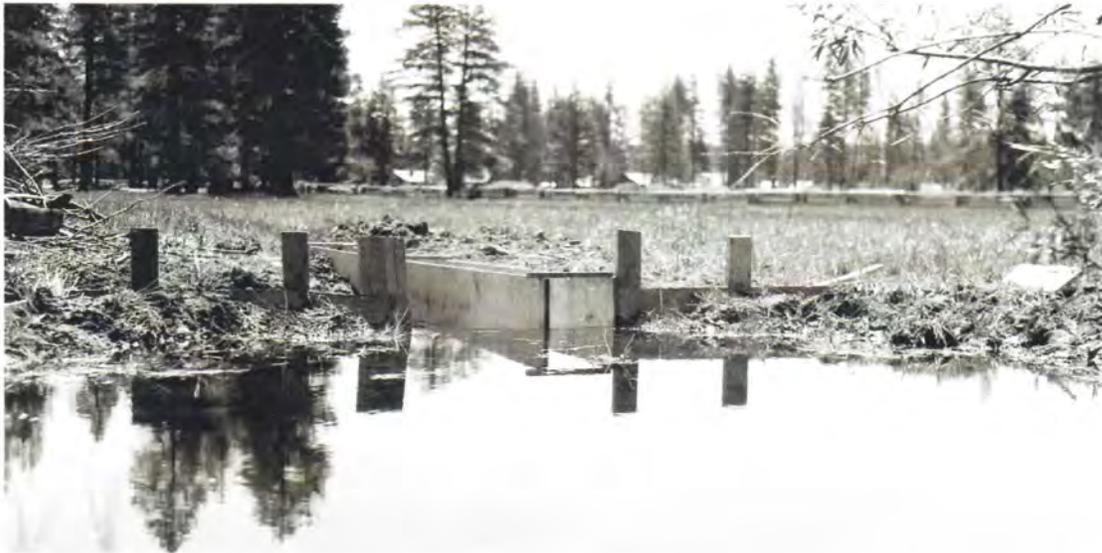
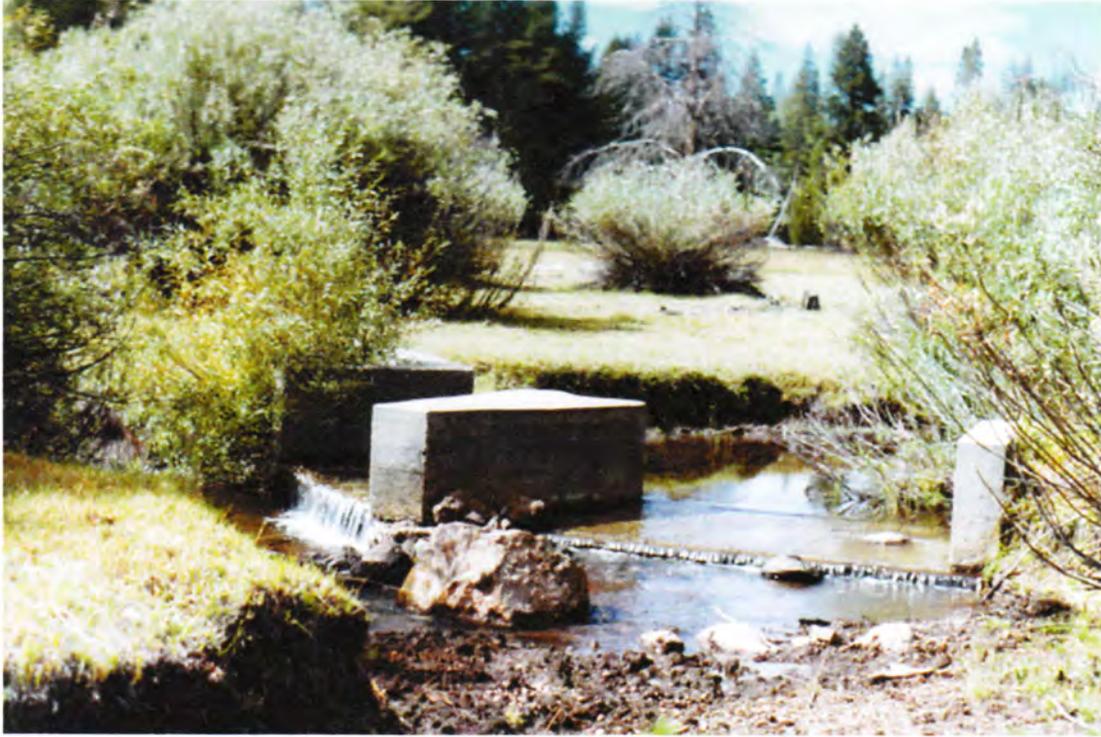
Figure 13. Splitter structure slightly downstream of the confluence of Pine Creek and Bogard Spring Creek (1939).

Figure 13a. Splitter structure (1978) downstream of confluence of Pine Creek and Bogard Spring Creek.

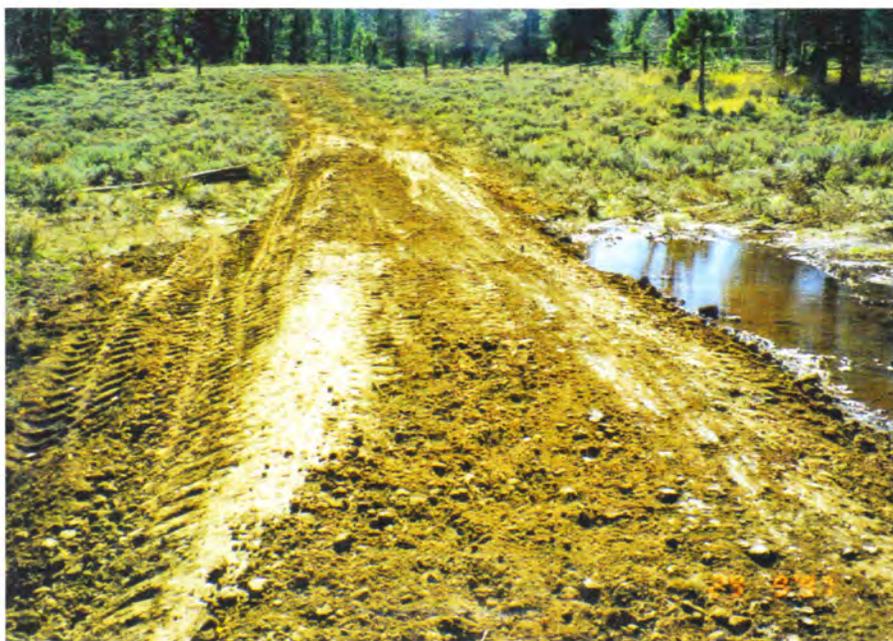
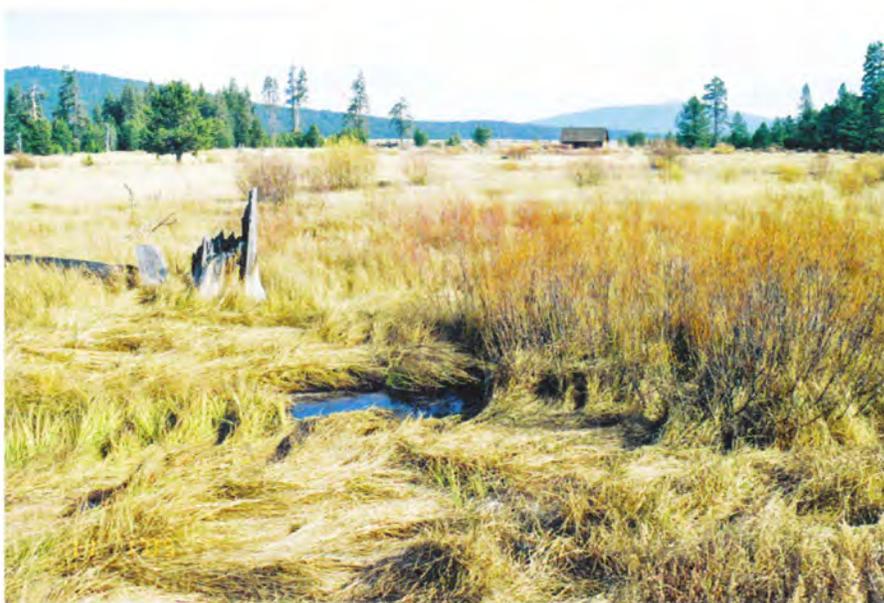
Figure 14. Top, earthen plug (1997) installed to block ditch and send flows back in to historic channels in meadow. Bottom, Pine Creek channel in 2005 after being re-routed out of ditch near Bogard Barn. Notice vegetation and stable banks along stream channel after 8 years of flow and after 14 years of no grazing.

Downstream of the splitter existed yet another ditch on the south side of the meadow. An earthen plug was installed at this location in 1997, directing flows into the braided middle channels of the meadow for approximately 1/4 mile until intercepted by road 31N19 (McKenzie Cow Camp road), then downstream in the southern branch of the stream.

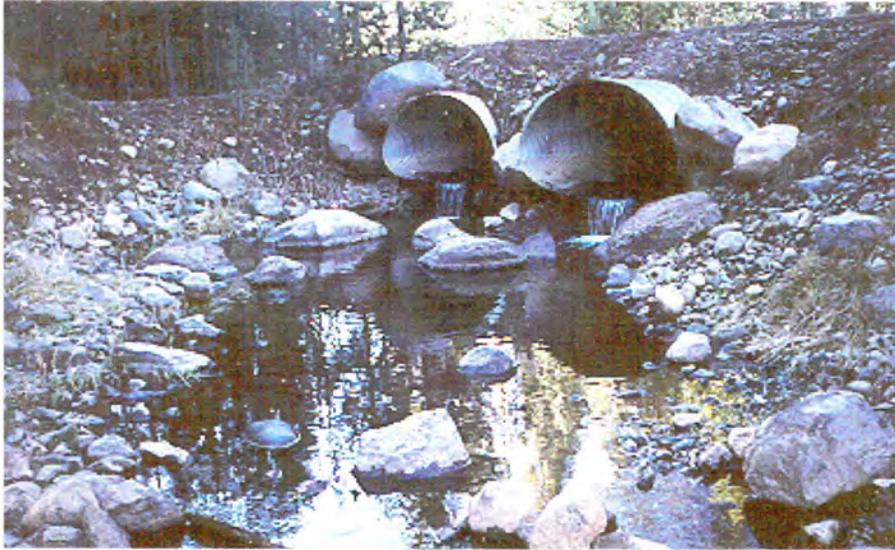
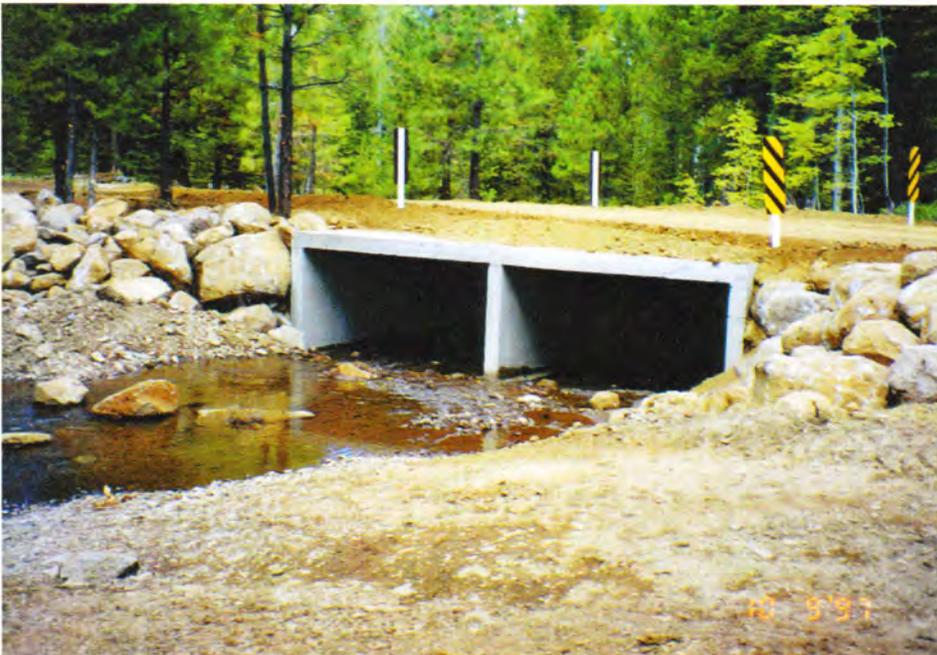
Figure 15. Top, corrugated metal pipe culverts in the early 1990's. Bottom, concrete box culverts to allow for fish migration and pass higher stream flows, 1997.

Identified as a potential fish barrier in 1989 by Young, a pair of culverts on forest road 32N22 were removed and replaced with a concrete box culvert with a natural bottom in 1997, using funding from the Knutson-Vandenburg (KV) Act for the Cone Timber Sale. The culverts, with their increased capacity, now handle higher flows and constantly maintain a low flow channel for fish passage.

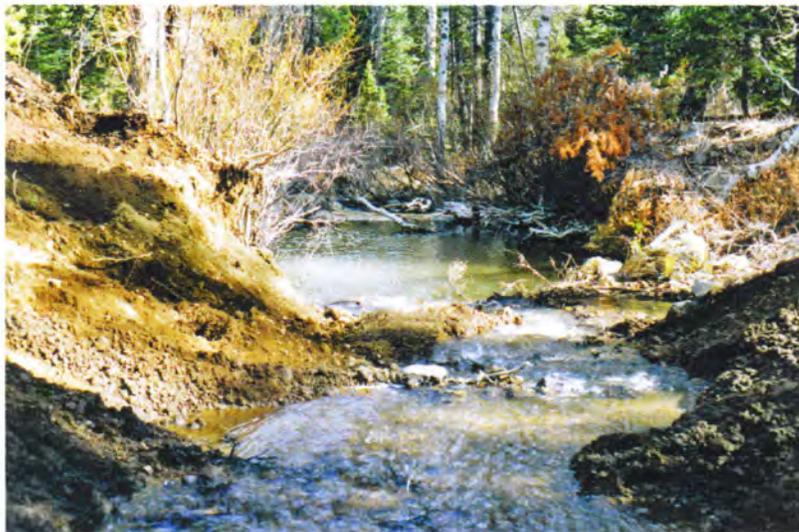
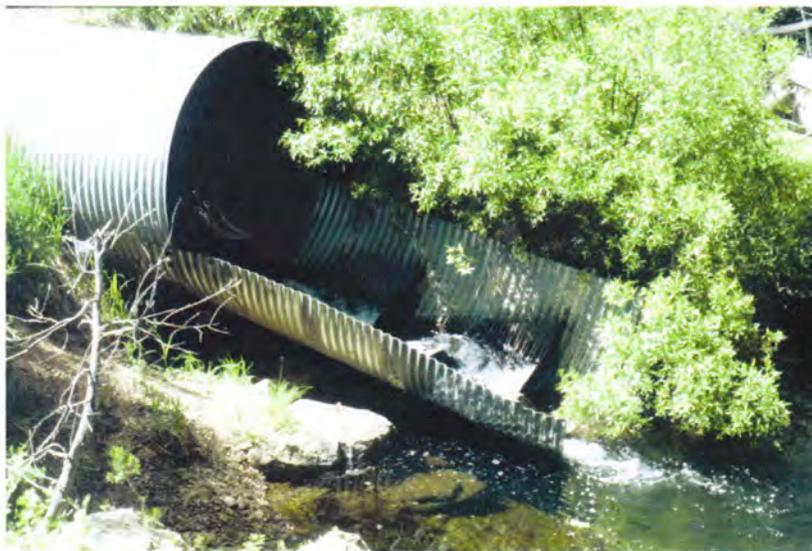
Figure 16. Top, Pine Creek looking downstream after removal of culvert and road crossing, 10/1997. Bottom photo showing baffles on lower end of culvert in an attempt to provide for fish passage 1978.

A known fish barrier on 31N08 was removed in 1997, along with closure of the road crossing. Initially estimated to cost a minimal amount, with the spoils sent to the railroad grade for berm work, costs rose substantially when extremely large boulders were found buried in the road fill. The stream over-wintered in an unfinished state, and further work to remove the boulders and widen the stream occurred in 1998. Forest Service crews scheduled to spread pine needles on site as a means of erosion control instead mistakenly spread needles on the lower 32N22 culvert replacement site. While the obliteration of the 31N08 road did not get accomplished according to the standards set up with the engineering department, within one season the stream had cut a stable path within the existing channel, and willow and aspen have now colonized the edges of the stream.

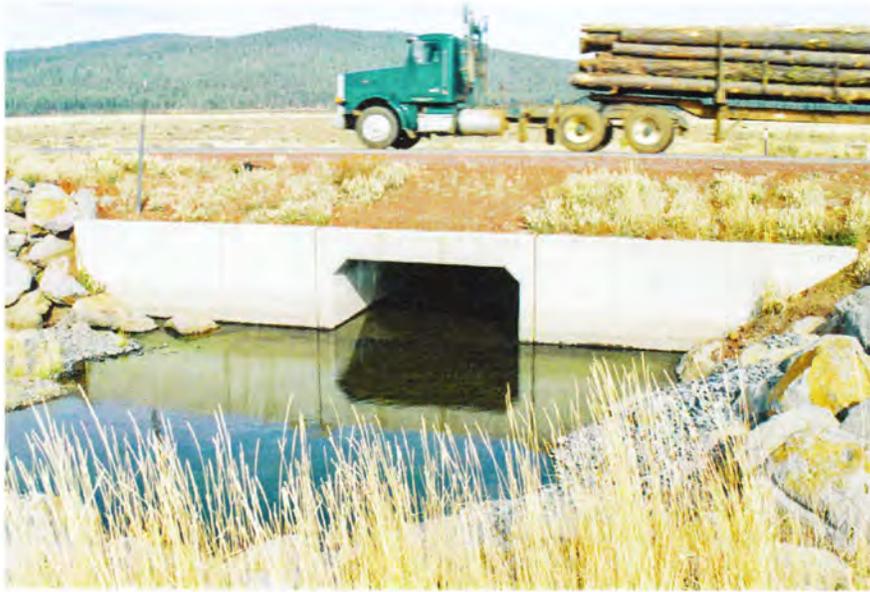
Figure 17. Culvert under Highway 44 on mainstem of Pine Creek, upstream side. 11/05.

In the fall of 1999, California's Department of Transportation (CalTrans) completed the replacement of culverts under Highway 44 across Pine Creek valley. Four culverts were

replaced along the width of the valley where multiple channels convey Pine Creek flow and were sized according to current standards to pass a 100-year flood event. Two culverts along the south side of the valley were constructed with a natural bottom, with one side functioning as a low-flow channel.

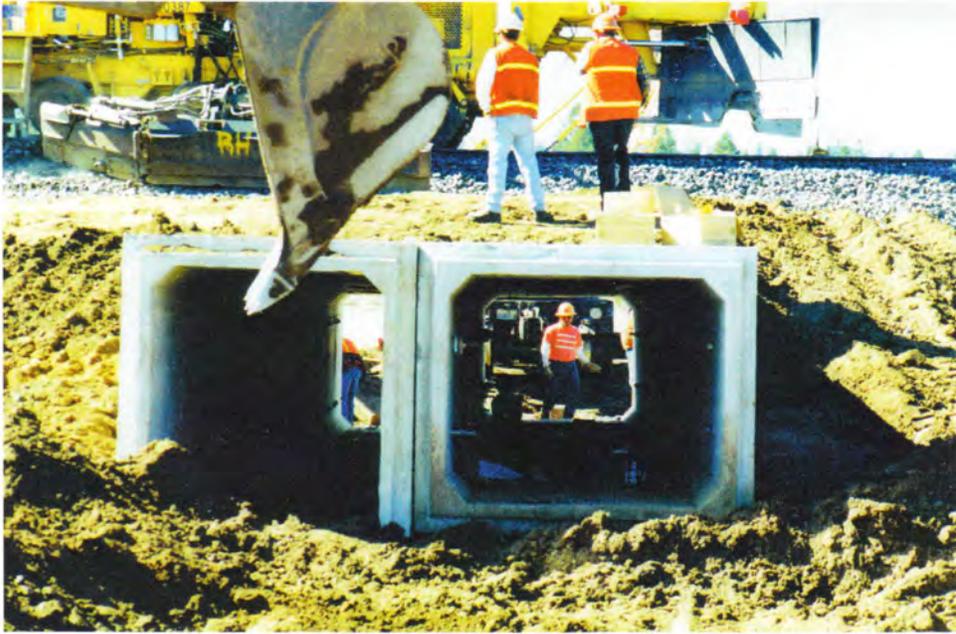
Figure 18. Concrete box culverts under BNRR line near Highway 44. Note left culvert installed on side and below grade to create fish passage channel.

New culverts (not replacements) under the Burlington Northern railroad grade (formerly Union Pacific Railroad, sold in 1998) were placed in September of 1999. This project was done in conjunction with a re-direction of flows of Pine Creek immediately adjacent to Highway 44 (upstream and downstream). The replacement of the Highway 44 culverts coincided with the planning and implementation of CRMP actions to rehydrate and reactivate the southern branch of Pine Creek. Payment for construction came from an Environmental Enhancement and Mitigation grant (EEM) through CalTrans, as well as in-kind contribution from the railroad, and appropriated FS funds. Construction of berms was necessary to direct flows into the main channel of Pine Creek to prevent unnatural drainage into the ditches, as each side of the railroad grade had borrow ditches that were lower than natural stream bottom. The construction of berms and placement of culverts was accomplished in 1999, prior to releasing flows into this historic channel (southern side of the valley), as well as again in 2005 to shore up weak spots.

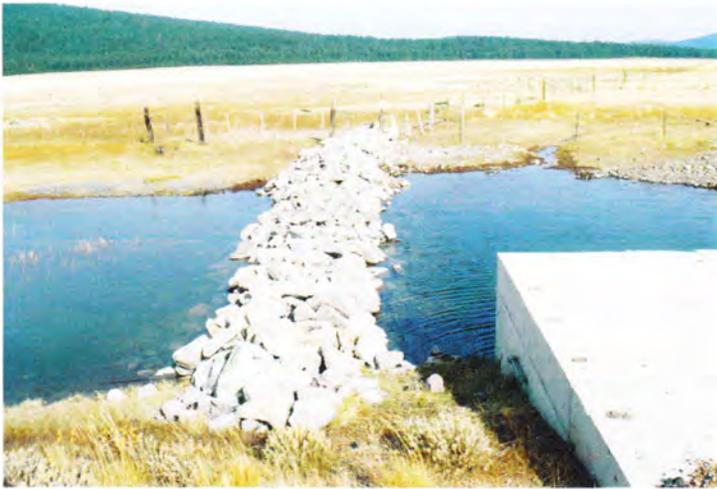
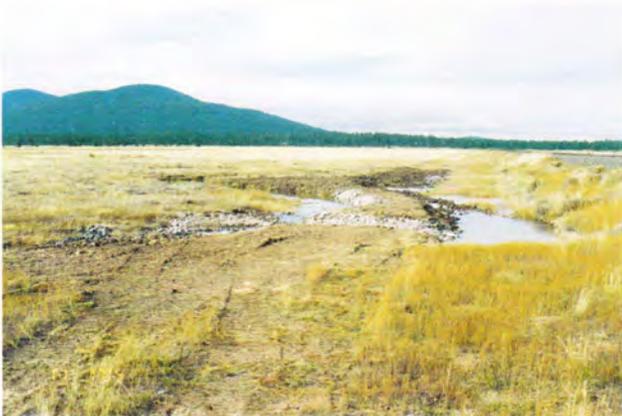
Figure 19. Berms constructed and/or repaired in 2005 to prevent or reduce flows into borrow ditches alongside BNRR grade in Pine Creek Valley.

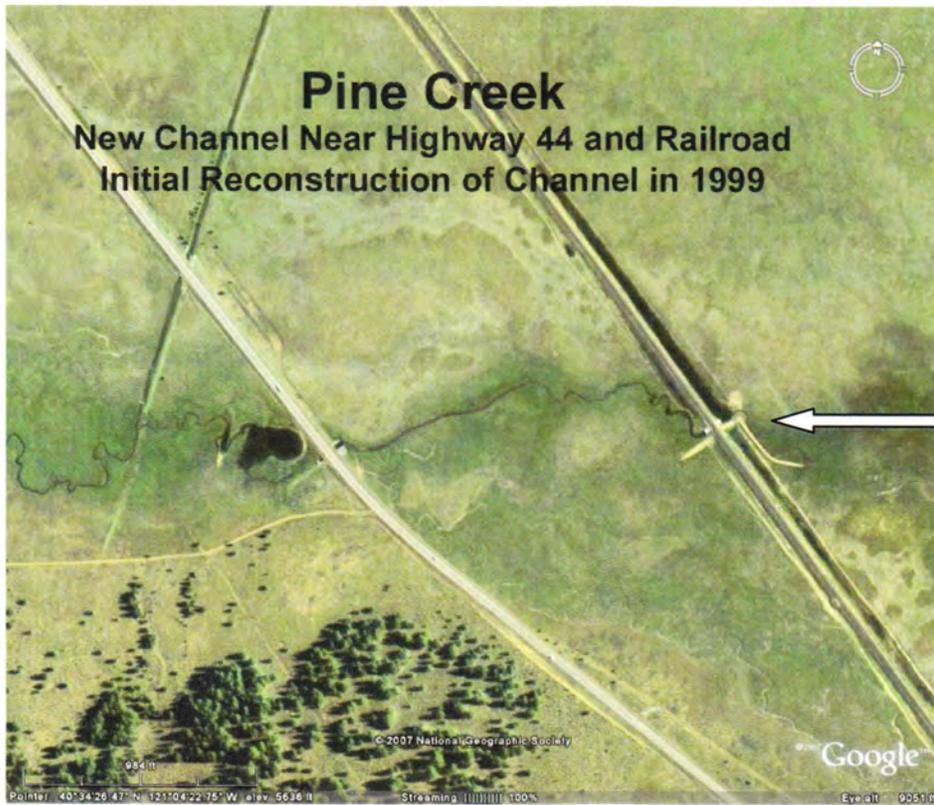
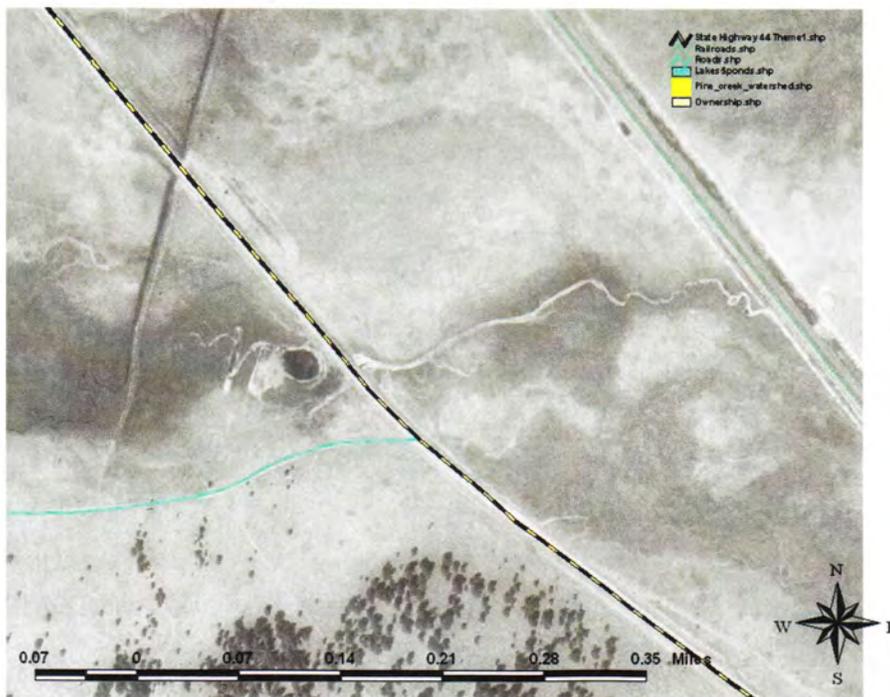
Figure 19a. Aerial images of, at top: reconstructed channel showing newly constructed berms downstream (see arrow), culvert at railroad grade, and berm removal upstream of the pond on Pine Creek, and bottom: channel as it existed from the 1950's through 1999, carrying only flood flow and draining alongside railroad line.

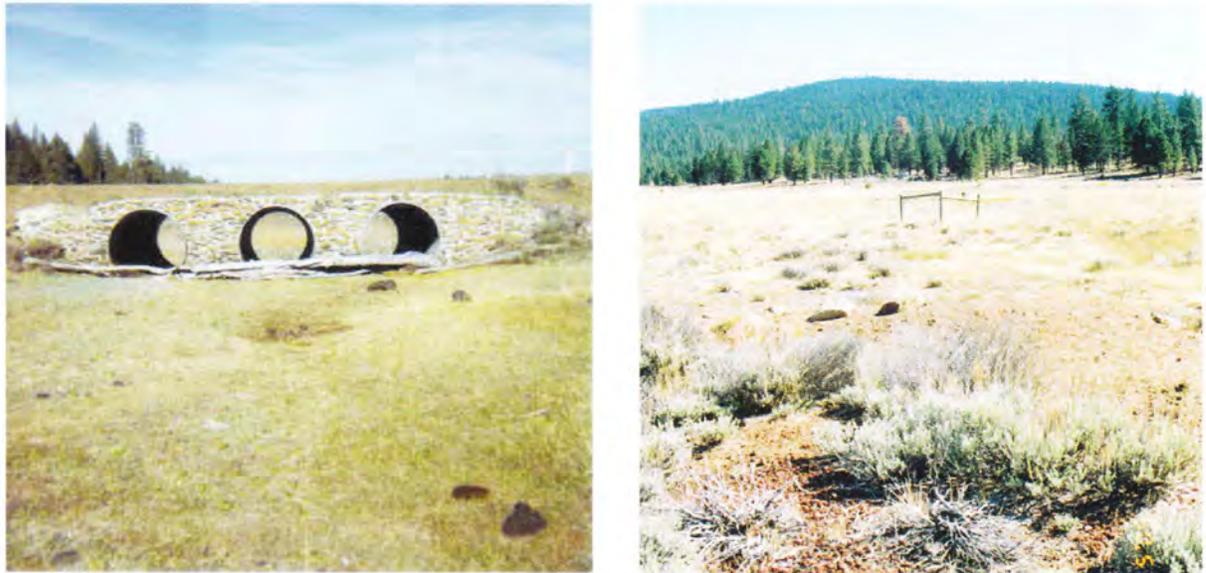
Figure 20. Left, culverts across Pine Creek from Harvey Valley Road crossing, 1976. Right, all road fill removed circa 1988, channel unimpeded and allows for fish passage, 2005.

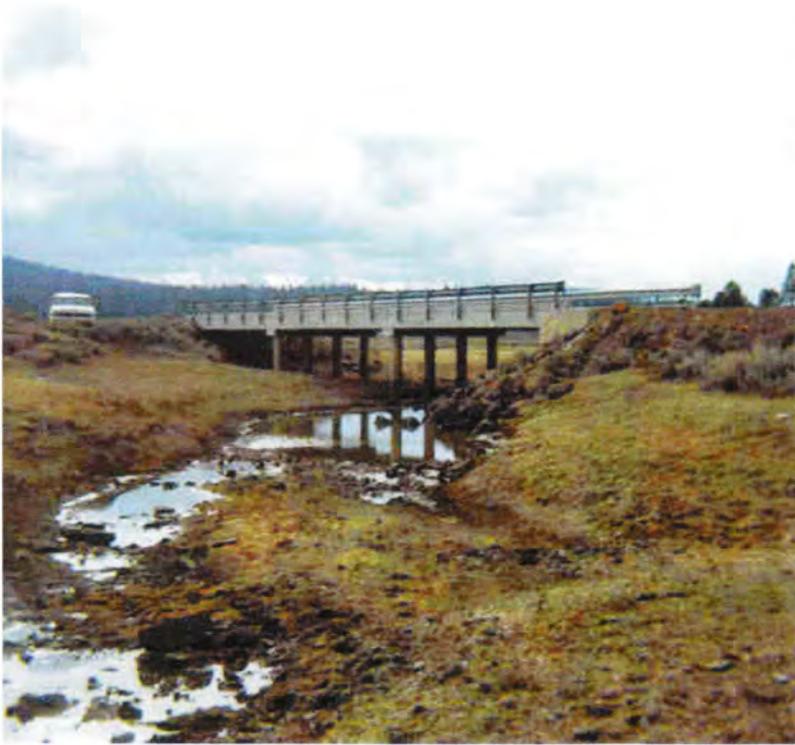
Figure 21. Million dollar bridge in 1976, top, and 2005, bottom. Note vegetated banks and willow in foreground of recent photo.

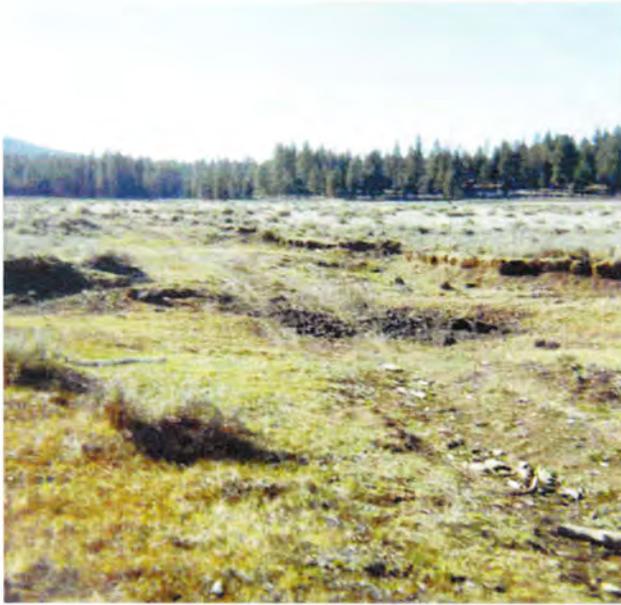
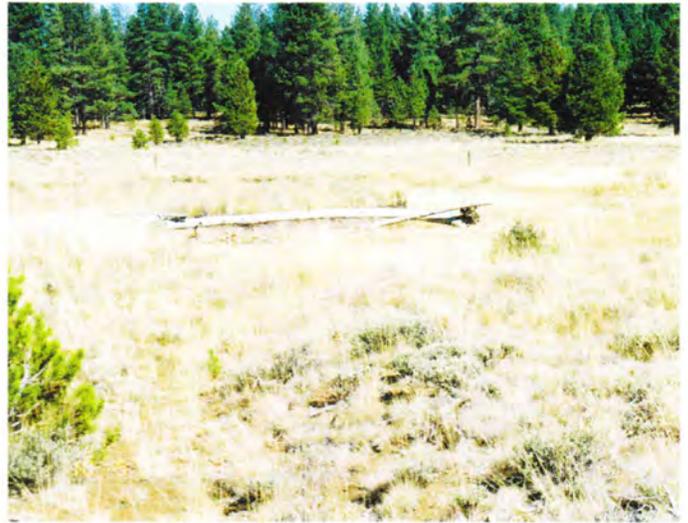
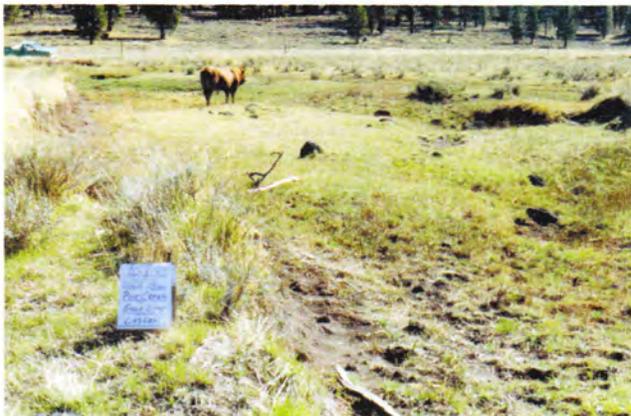
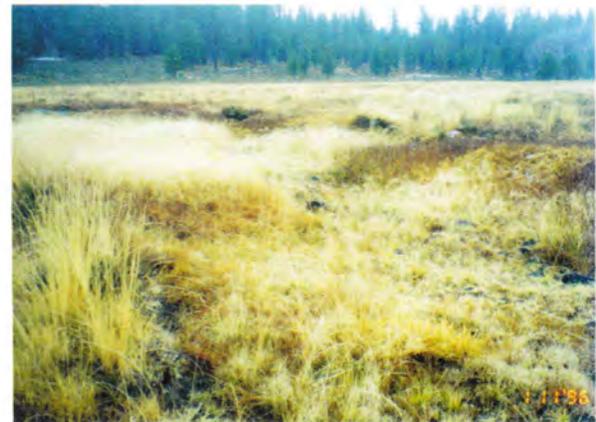
Figure 22. Logan Springs road

obliteration completed circa 1988. Upper left, looking northwest across Pine Creek, 1976. Upper right, looking east across Pine Creek where old road once crossed, 2005. Lower left, looking southeast in 1993 prior to enclosure fencing. Lower right, looking southeast after two seasons of cattle exclusion, 1996.

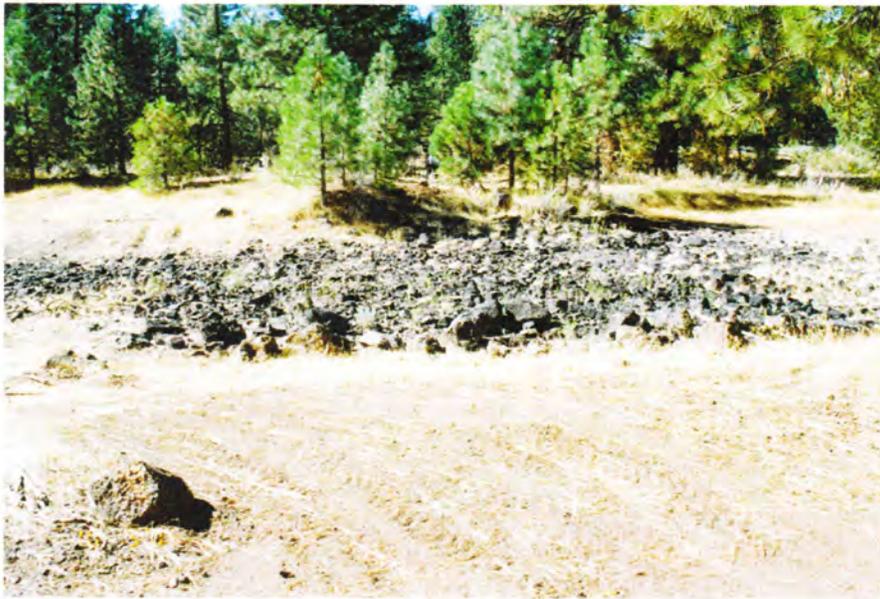
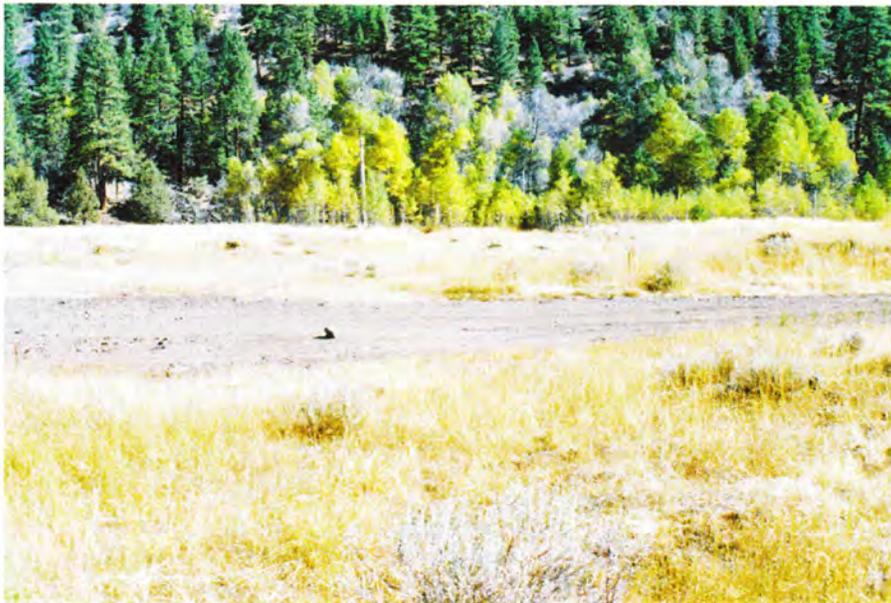
Figure 23. Top, former road crossing of Pine Creek at Pine Bridge campground (Road 33N93A). Note vehicle tracks in foreground where users have bypassed the road block. Bottom, Corbin crossing (Road 33N93), a hardened location on natural streambottom and impassable to vehicle traffic during high spring runoff. Channel flows downstream from this location.

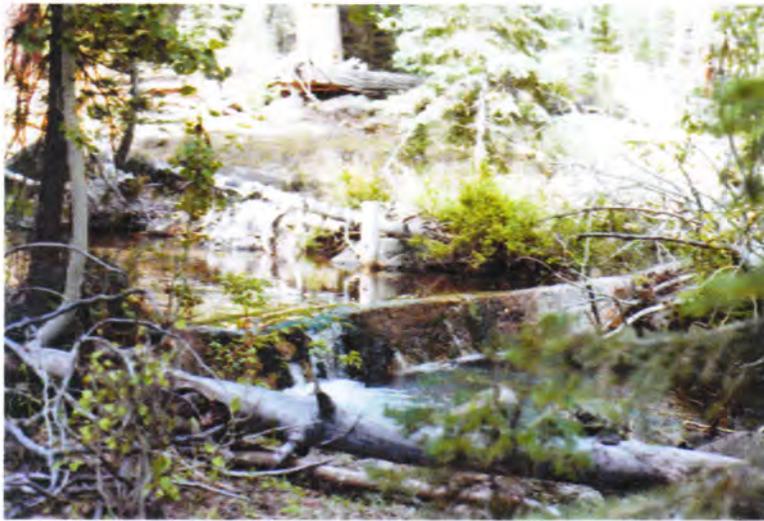
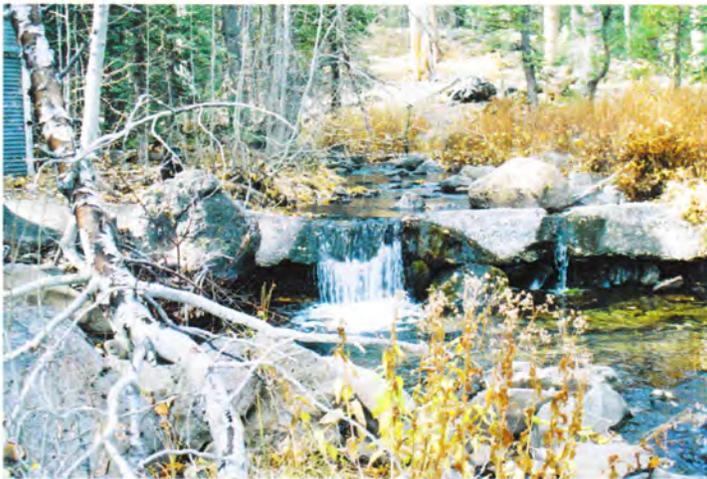
At the present time, the depth from the bottom of the stream to the top of the dam is approximately 5.5’. CRMP participants raised concerns in 2002 that fish passage may be impeded, and upstream passage is certainly blocked for all fish during low summer flows. The structure, while seemingly forming a stable part of the stream bottom, is an unnatural and unnecessary feature within the channel. Plans were developed to remove the structure until it was learned that a monitoring project associated with aspen stand enhancement in close proximity to this site was already in progress. As part of a multi-year monitoring effort, changes to the stream bed, sediments, or water quality may affect the results of the study and the plan to remove the concrete weir are on hold for another 2-4 years (2008 at the earliest, Rickman pers. comm.).

Figure 24. Top, gaging station weir 1979 (note height of dam). Bottom, weir in 2005, showing erosion under concrete apron.

The actual jump height at the weir is 36", while the pool depth is 30". It would appear from the above formula that the jump is 12" too high. However, other measurements published of the jumping ability of fish, salmonids in particular, are: an 8-12" brook trout can ascend a 29" barrier from a 24" deep pool (Myrick et al 2004), a cutthroat or rainbow trout (adult, no length given) can ascend a 59" barrier from a 74" deep pool, while a juvenile rainbow or cutthroat (approximately 6") can ascend a 24" barrier from a 30" deep pool (Parker 2000). It is unknown at this time whether or not Eagle Lake trout can migrate past this barrier on Pine Creek. From the information listed above, one could make the case that the pool depth is not great enough to support the lift the trout would need to propel itself over the weir, but measurements of the pool depth during spring runoff conditions have not been calculated. It appears that the brook trout of the first example listed above could come close to leaping the barrier as it now exists and as measured during summer flows. In any case, the weir does look to be a complete barrier to upstream migration for smaller fishes during low flows. Of greater interest may be the drop in downstream elevation at the site. As measured in 1979, the drop from the top of the dam to the stream bottom was 30", and measured in 2004, was 66". The drop in elevation (based on photographs comparing the site in 1979 and in 2006) may be related to the road crossing below the weir site.

Fish TRT notes from 2004 indicated an interest in removal of the concrete weir. Relying on the following formula (CDFG 1998a) to indicate the ability of a salmonid to ascend an obstacle, calculations were made to assess this potential problem:
