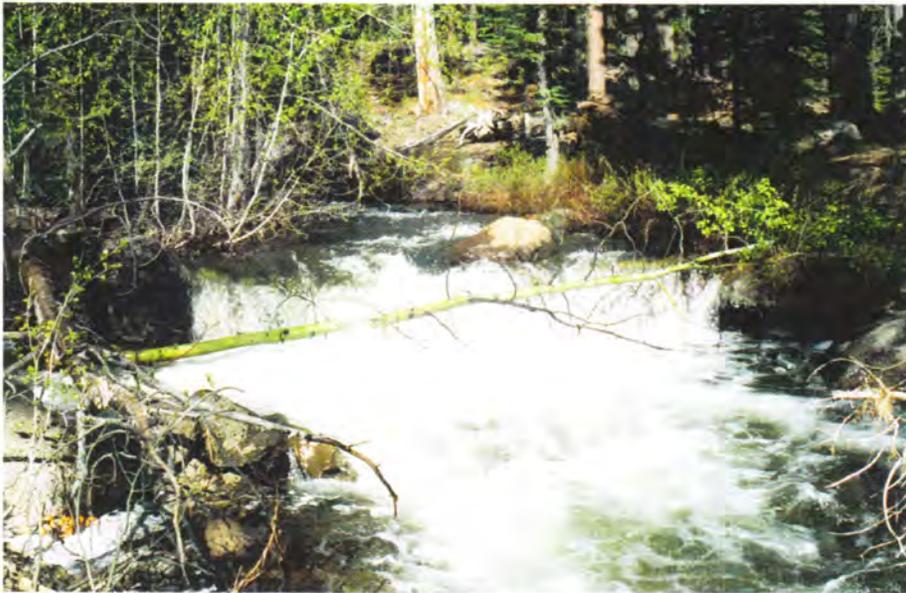
Figure 25. Gauging station weir in late spring 2006. There is some disagreement amongst fisheries professionals on whether or not this poses a barrier for ELRT during runoff conditions.

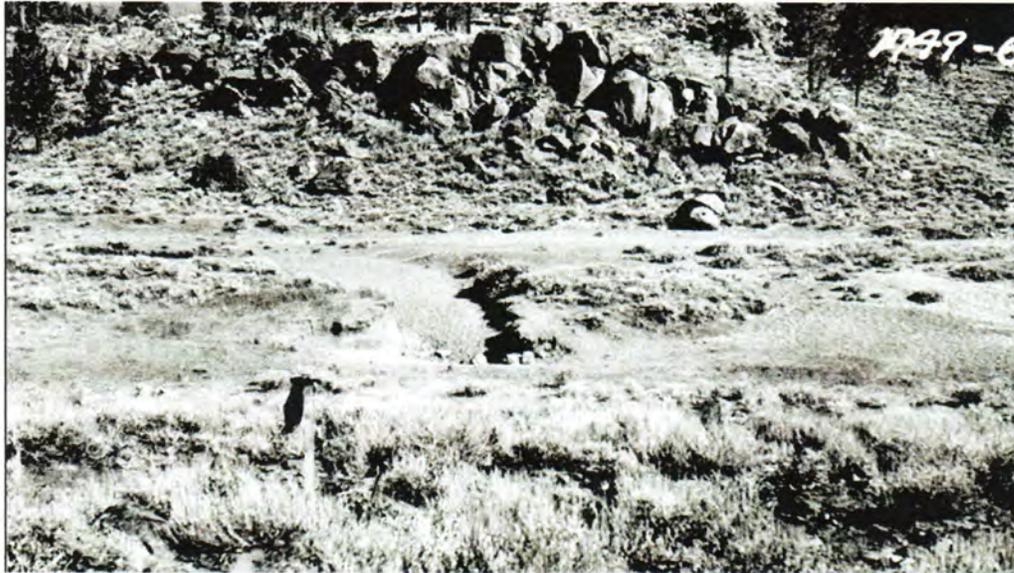
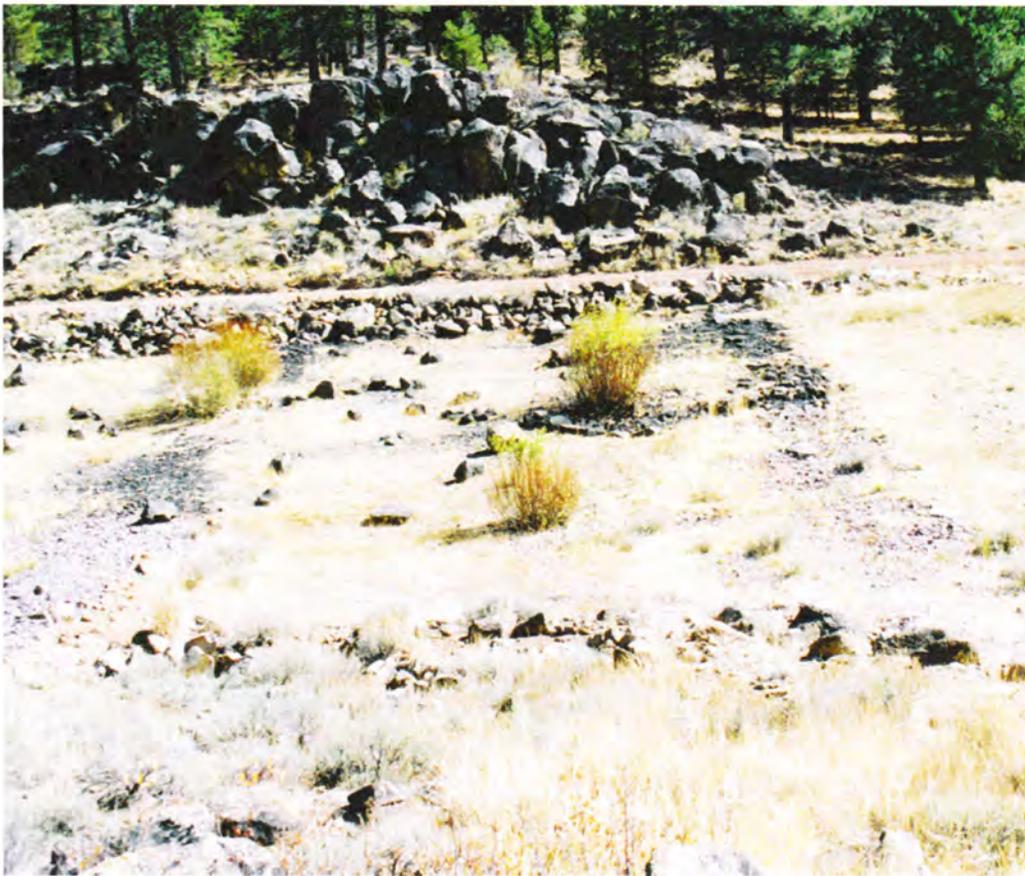
Figure 26. Top, area near Bradford Crossing circa 1936. Bottom, 2005.

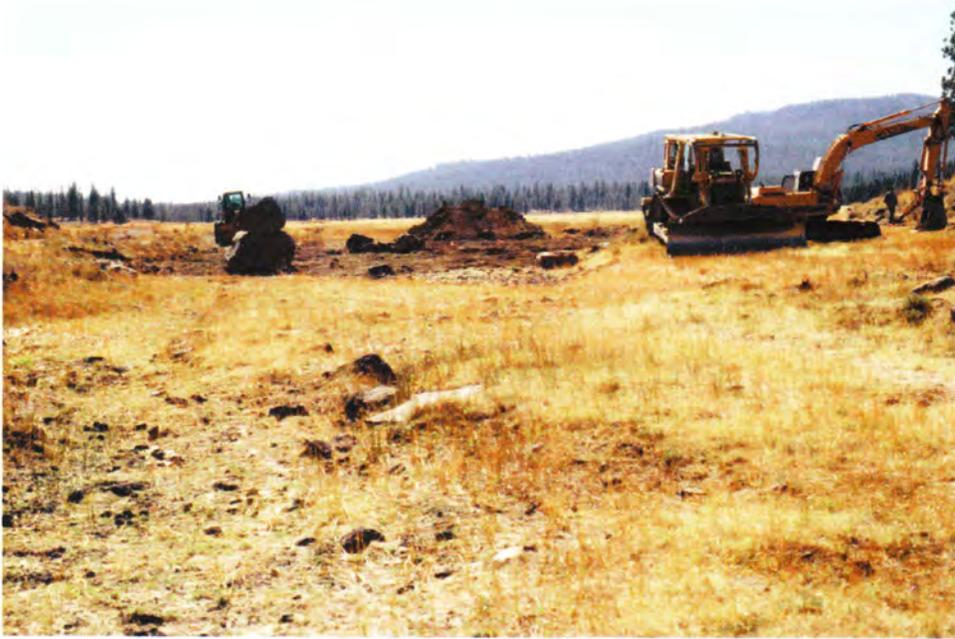
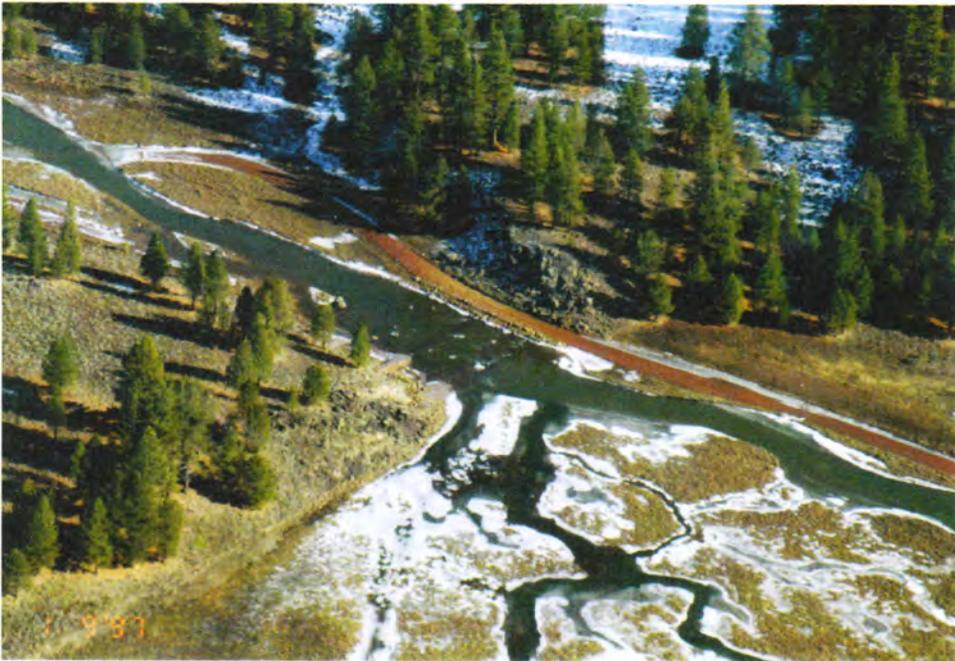
Figure 27. Above, Bradford three-step rock structure constructed in 1995. Bottom, aerial view showing stream backed up into the valley.

After years of consideration, one such structure was built at an area known as Bradford crossing, downstream of Harvey Valley confluence with Pine Creek and upstream of Champs Flat. This location may have been one of the sites from Meadowcroft's 1936 reconnaissance report of water retention structures. The design for the present structure came from CRMP participant Natural Resources Conservation Service, formerly the Soil Conservation Service. Instead of one high structure to retain water, NRCS engineers, after coordination with CRMP due to fish passage concerns, designed a three step structure, with each step being one foot higher than the downstream dam. This design was adopted and the structure was built in 1995. It was calculated that the structure would back up water nearly 5/8ths of a mile, into the Harvey Valley allotment (CRMP 1993). Concerns were raised about impeded fish passage and/or increased water temperatures, with the caveat that the structures would be removed if either situation occurred. Cost of the structure was \$27,000, of which \$8,000 was EPA source funds (CRMP 1995). Willows have pioneered the site and are increasing in vigor and number. ELRT have passed over the series of structures, and in conjunction with a fence to eliminate livestock use upstream of the structure, vegetation is rebuilding on streambanks and in the flat valley. Willows are beginning to appear on and upstream of the structures, along Pine Creek just above the junction with Harvey Valley Creek.

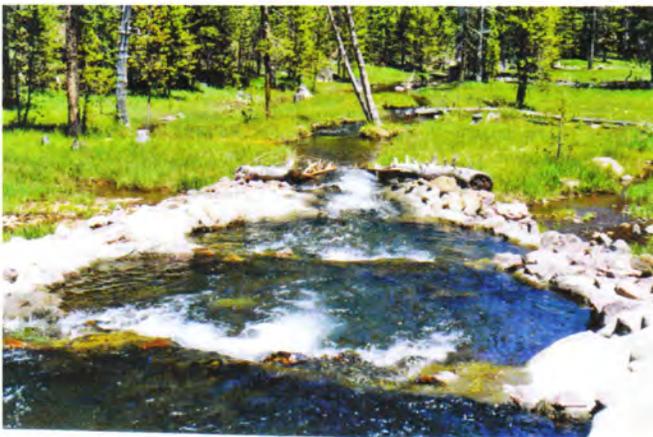
Figure 28. Above, culvert outlet at road 31N25, the outlet of Leaky Louie's pond 1990. Below, fish ladder constructed below Leaky Louie's pond in 1994, near the headwaters of Pine Creek.

Fish passage was and continues to be important to the goal of providing unimpeded fish passage to and within the seven miles of perennial headwaters. Perhaps prematurely, the FS, after CRMP involvement, chose to construct a fish ladder to allow for migration from Stephen's Meadow to Leaky Louie's pond. CRMP notes indicate that discussions occurred over timing of construction (ie, ELRT were not yet in the headwaters), and the minimal amount of habitat available upstream. The ladder was constructed in 1994 using CDFG funds that were leftover from fencing projects downstream. This ladder is fully functioning and should easily allow for passage of ELRT if and when necessary.

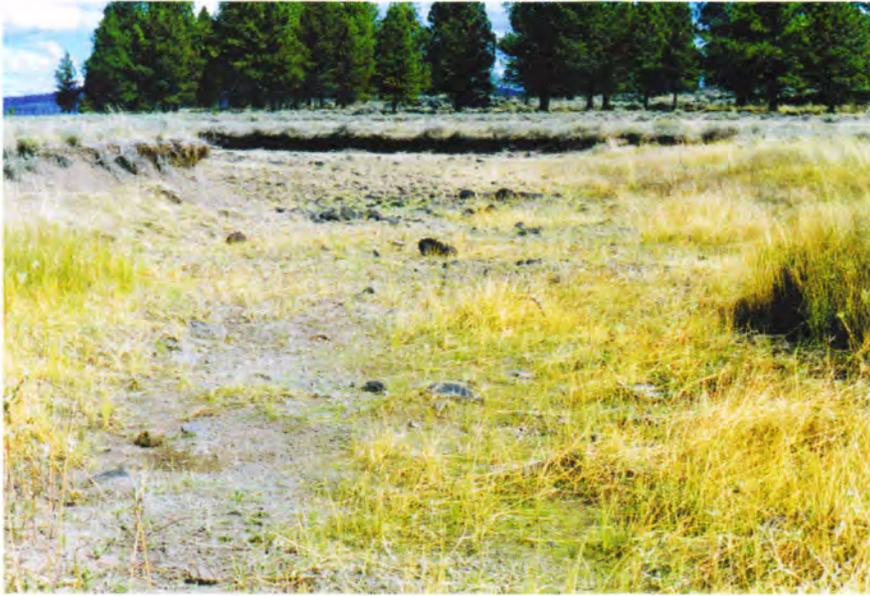
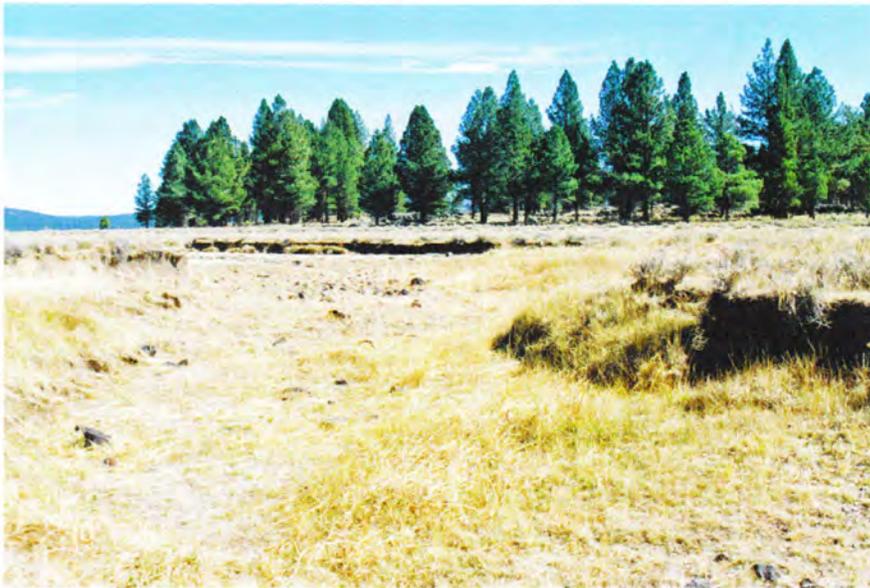
Figure 29. Champs Flat channel cross section. Top, 1997. Bottom, 2006.

An early advocate not only for establishment of the CRMP process but also for an assessment of long-term trends was Tom Troxel of the USFS. Troxel established channel cross-section points along Pine Creek in 1988. The intent was to read the cross-sections every 2 years in order to determine whether or not the stream channel was changing, hopefully in response to better management practices or projects to improved ecological conditions. Read initially in 1988, follow-up data were collected in 1992, 1995, and 1997. More cross sections were added in 1995 in order to monitor sites further upstream. The National Riparian Service Team (1998), recommended reading the cross sections every five years, or further, apart. Channel changes at the scale measured aren't likely to present themselves at two-year intervals. Some very useful data that is available from these locations are the photos that are taken from a known point. Visual estimates of change are easily discernible. Funding for this monitoring came from EPA 319 grant funds for 1992 and 1995, and FS appropriated dollars were used in 1997.

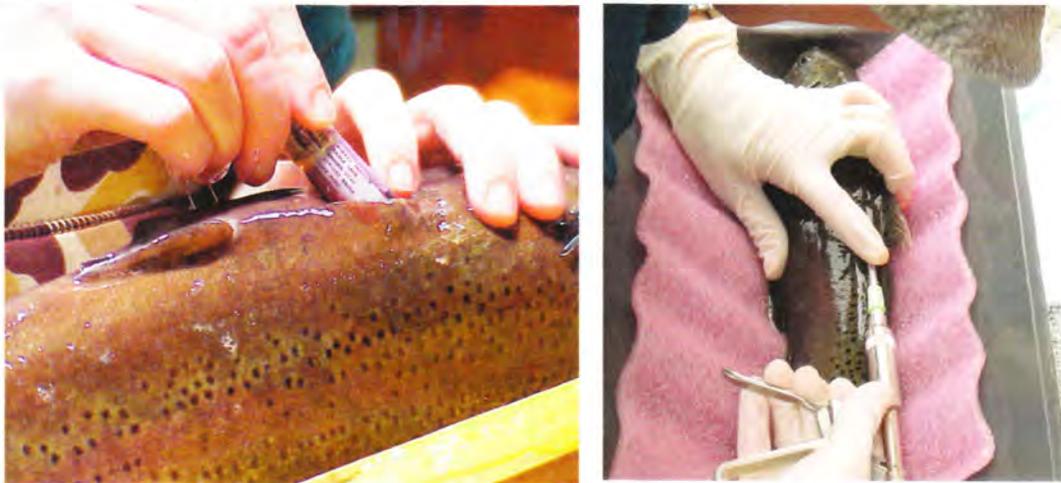
Figure 29a. Two methods used to track upstream fish migration. Left, radiotracer surgically implanted into body cavity. Right, PIT tag inserted under skin.

The transmitters that were selected would emit a radio signal and collect water temperature data in order to provide information on water temperature of holding places or travel corridors, as well as to provide an electronic trail fish migration. The mortality signal option allowed for retrieval of the transmitter if/when mortality occurred. When the carcass was found, biologists could examine the condition of the carcass and determine possible cause of mortality.

ELRT were collected during the spawning season at the Pine Creek fish trap and transmitters were surgically placed in selected migrating fish. Tracking crews searched for signals of tagged fish to accurately monitor their upstream progress. Transmitters were first implanted in ELRT in 1999, but results were difficult to interpret, as it was discovered that other electronic equipment within the Pine Creek corridor easily interfered with the frequencies chosen. Fish that were released were “lost” for a period of two weeks, during which time their whereabouts were completely unknown. Ten unmarked, untransmitted fish were released along with the 10 fish, and two of these may have been seen in upper Pine Creek Valley in mid-May on a canoe trip downstream from Highway 44 to track the transmitted fish. In early June, a single radiotransmitter, sans trout, was recovered in Bogard Spring creek above the 32N22 road, a distance of 3.6 miles above Highway 44.
