IV. Conservation Actions

C. Watershed, Riparian, and Aquatic Habitat Restoration

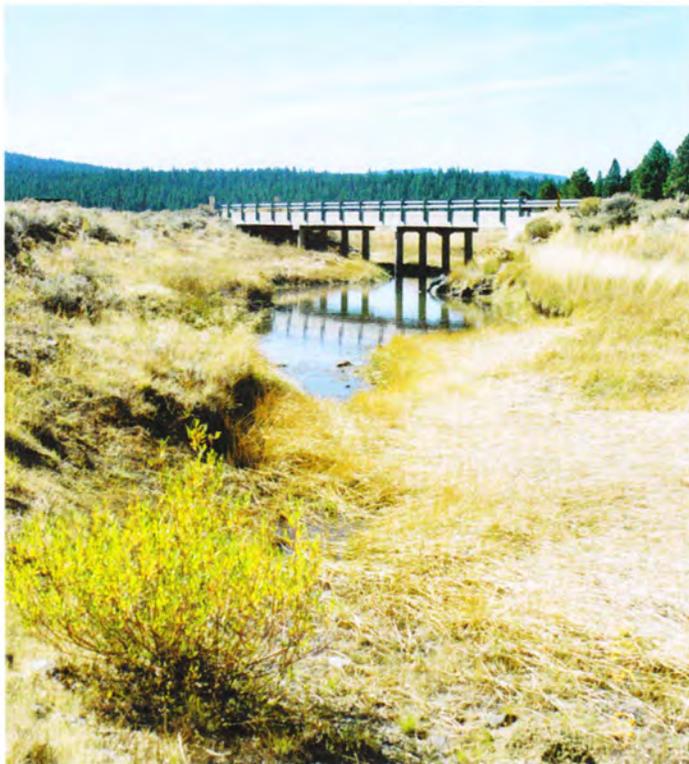
Figure 21. Million dollar bridge in 1976, top, and 2005, bottom. Note vegetated banks and willow in foreground of recent photo.
